## WELD REPAIR OF GEOTHERMAL TURBINE ROTORS

Craig E. Chaney

Pacific Gas and Electric Company, Engineering Dept.,  
77 Beale St., San Francisco, CA

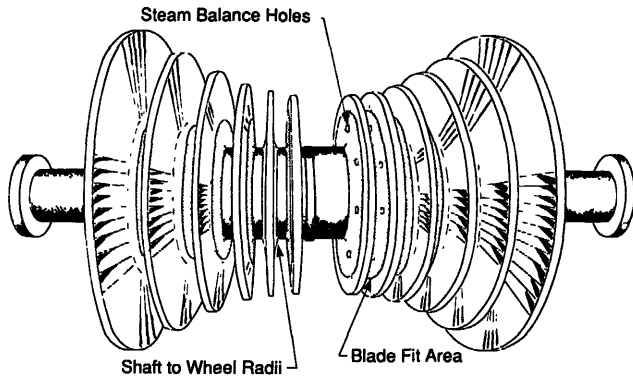
Figure 1 shows where SCC occurs on the rotor. These areas are the shaft-to-wheel radii on the second and third stages, the steam balance holes in the second stages, the notch block holes on stages 1 thru 5, and the hook radii in the blade attachment area of stages 1 thru 5. All of these areas are the high stress regions of the rotor that have stress levels between 145 to 310 MPa (21 - 45 ksi).

Figure 1. Wide Angle View of Turbine Rotor Showing Locations Where SCC is Predominant

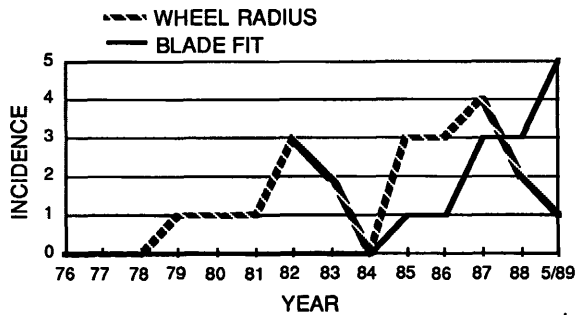
Since 1979, PG&E has been discovering SCC in their turbine rotors at an increasing rate. Figure 2 shows the number of incidents of rotor SCC found per year in the two primary SCC areas of PG&E rotors: shaft-to-wheel radii and the blade attachment area.

Figure 2. Incidence of Turbine Rotor SCC Per Year at The Geysers

Figure 2 also shows that the incidence of cracking in the shaft-to-wheel radii has recently started to decline. This decrease is attributed to the routine shot peening that has been performed in these areas over the past six years. The shot peening induces residual compressive stresses into the rotor surface and thereby increases the time for SCC to initiate. However, this compressive surface layer can be corroded or eroded away during service, which makes it necessary to re-peen at intervals depending on the steam conditions in the turbine.

In contrast to the shaft-to-wheel radii, the blade fit areas of the rotors have experienced increasing incidences of cracking. The large increase in 1989 can be partially attributed to the inspection efforts to detect cracking in this area. However, prior to the increased inspection efforts (before 1988), the total number of occurrences per year had gradually increased over time, which indicates that the increased incidence of cracking is attributable to factors other than inspection

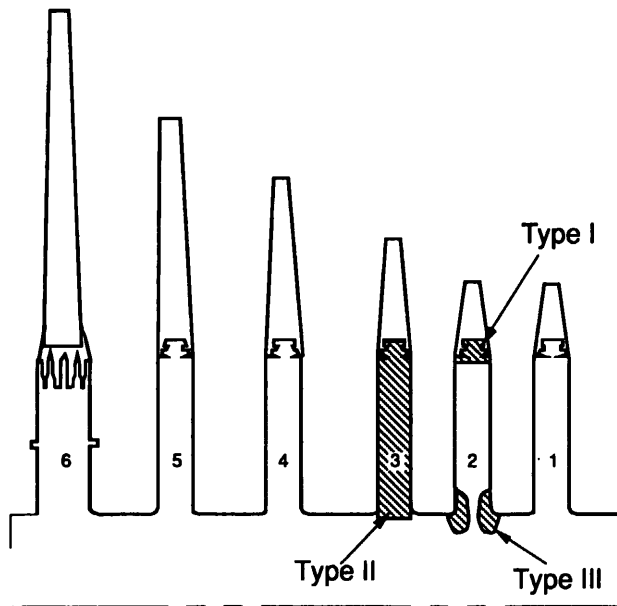
A Type I repair is the repair of the blade fit region where either SCC has occurred to a depth that violates design standards or the fit is sufficiently deteriorated so that the clearances between the blades and the fit are excessive and may jeopardize blade life.

A Type II repair is used to rebuild a wheel that has been previously machined off at the rotor shaft surface. The wheels were removed due to extensive cracking at the shaft-to-wheel radii. The entire wheel, approximately 89 cm (35 in.) in diameter, is rebuilt with weld filler material.

A Type III repair is for the repair of SCC at the shaft-to-wheel radii. This type of repair was performed on a rotor in 1983. However, the rotor was only recently returned to service due to the metallurgical concerns.

Figure 3. Primary Types of Weld Repairs on The Geysers Turbines

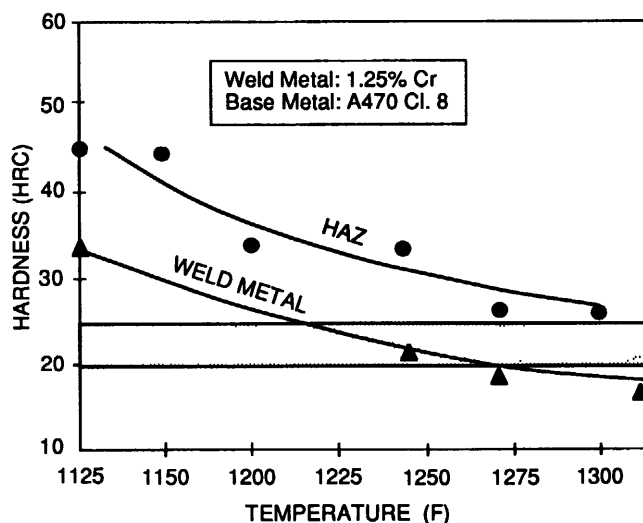
Figure 4. Tempering Curve for a Welded CrMoV Rotor Material (HRC reading converted from actual HK readings.)

Figure 4 is a tempering curve of a heat affected zone of an ASTM A470, Class 8 (CrMoV) turbine rotor forging that was welded with a 1.25% Cr filler material. This curve demonstrates the balancing act between maintaining weld metal strength and minimizing HAZ hardness. The minimum specified tensile strength of 690 MPa (HRC 20) for the rotor could not be achieved if the rotor was post weld heat treated at 720° C. A 720° C temperature for post weld heat treatment would be desirable because it would temper (soften) the heat affected zone to HRC 25, which would be less susceptible to SCC than a HAZ with a higher hardness. However, at this temperature Figure 4 shows the weld metal would fall below the minimum tensile requirements of 690 MPa (HRC 20), which would be unacceptable. A compromise in post weld heat treatment temperature of 690° C was made to keep the weld metal

strength above the minimum of 100 ksi and the final hardness of HRC 28.

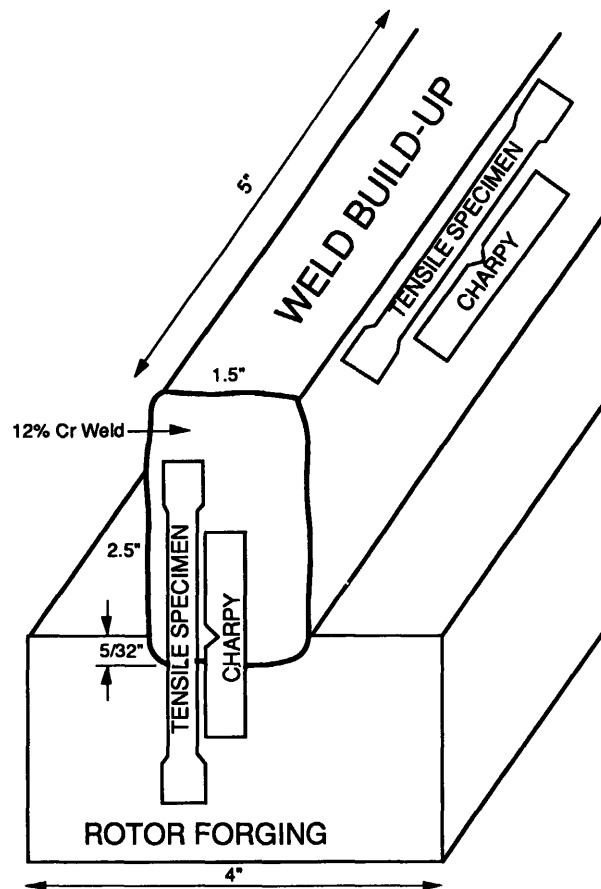
Figure 5. Rotor Weld Qualification Blocks

The test block configuration shown in Figure 5 would be suitable for Type I and II repairs. However, the orientation of some of the test specimens should be altered somewhat for the Type I repair to reflect the change in the orientation of crack growth in service.
