WELD REPAIR OF GEOTHERMAL TURBINE ROTORS
A PARTNERING APPROACH
BY
PACIFIC GAS AND ELECTRIC CO. AND ASEA BROWN BOVERI

Donna L. Schubert⁽¹⁾ Michael D. Morin⁽²⁾ Timothy W. Hollingshead⁽³⁾

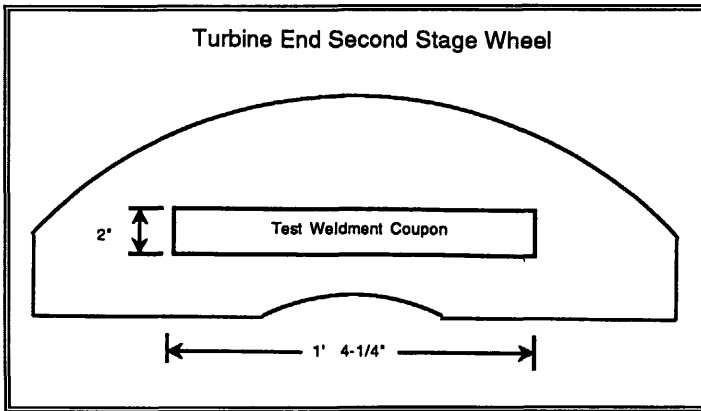
Figure 1 - Test Weldment

The test weldment base metal was removed from the Rotor 14A second stage wheel as shown in Figure 1. Hardness measurements were made on the Rotor 14A material prior to welding. Previous testing had established the material's tensile properties prior to welding in the thru-thickness direction in a area of the wheel comparable to that from which the test coupon was removed.

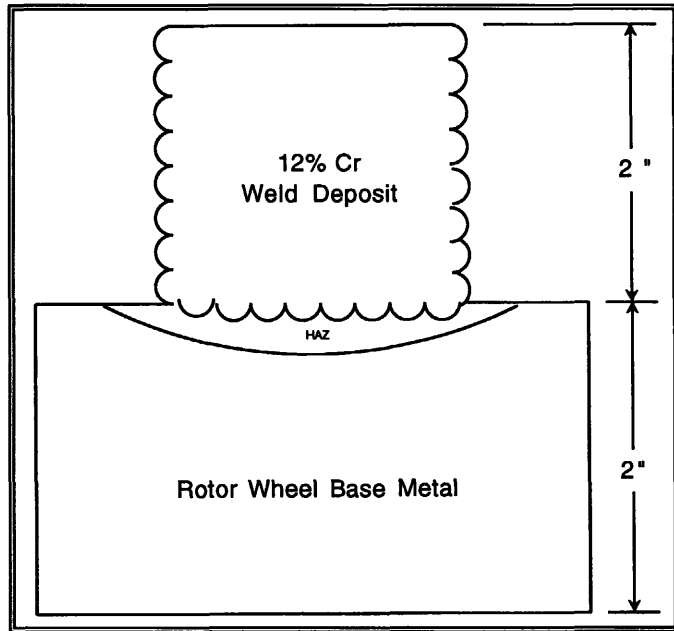
Figure 2 - Tensile Testing Specimen

Following heat treatment, the coupons were prepared for hardness evaluation and specimens were removed for tensile testing as shown in Figure 2. Forty Equotip hardness traverses were made across the weld deposit and unaffected base metal and 40 Knoop microhardness traverses were made across the base metal HAZ. The hardness results (calculated as 95% confidence intervals and converted to the Rockwell C or Rockwell B scale) and tensile test results (for transverse composite tensile specimens) for each PWHT temperature are shown in Table 2.

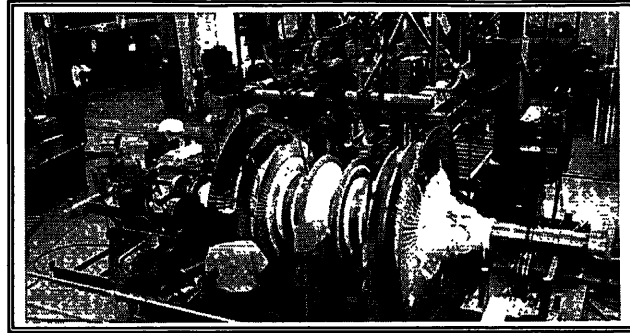
Figure 4 - Saw Set-Up

Next, the rotor was set up in the submerged arc welding (SAW) station (see Figure 4). Since the 12%Cr weld build-up material is air hardening, the complete weldment must not be allowed to cool excessively prior to the application of the PWHT. This makes it necessary to attach as much of the resistance heating equipment as possible prior to the start of preheating. In other words: Once the preheat/welding has commenced, the rotor is not allowed to cool until after the completion of the PWHT cycle. In preparation, the rotor is coated with a protective solution to guard against scaling during the high temperatures of the PWHT cycle.
