## High Temperature Field Testing of Polyphenylenesulphide Composite Coatings

Toshifumi Sugama<sup>1</sup>, Paul Hirtz<sup>2</sup> and Keith Gawlik<sup>3</sup>

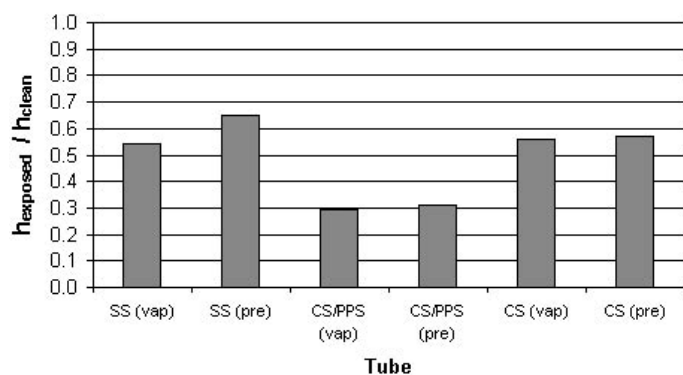
The heat transfer results are summarized in Figure 2. The results for interior heat transfer coefficient,  $h$ , which consists of interior convection and conduction through the scale layer, after exposure are normalized with respect to performance when new. Three sets are shown in the figure—stainless steel (SS), PPS applied to carbon steel (CS/PPS), and uncoated carbon steel (CS)—for tubes that were installed in the vaporizer (vap) and preheater (pre) heat exchangers. The stainless steel tubes show a 35-46% drop in interior heat transfer rate with exposure. The uncoated carbon steel tubes show a 43-44% decline, while the coated tubes had a drop of 70%. The interior heat transfer coefficients for the SS tubes and CS steel tubes declined less in the preheater than vaporizer, consistent with the amount of scale deposited and the silica scale thermal quenching effect, as discussed later under Scale Thickness and Scaling Rates.

Although the coated and uncoated tubes experienced scale accumulations to varying degrees, the coating had largely disbonded, leading to significant additional heat transfer resistance. Disbonding was not observed for the PPS-coated

carbon steel coupons that were installed in injection brine pipelines. The coupons were coated by BNL, and the tubes by the commercial coating company, leading to the premise that application technique by the commercial coater was faulty. Failure mechanisms were explored by BNL and a likely cause has been found, as will be described below.

**Figure 2.** Heat transfer performance of the exposed tubes compared to new tubes.

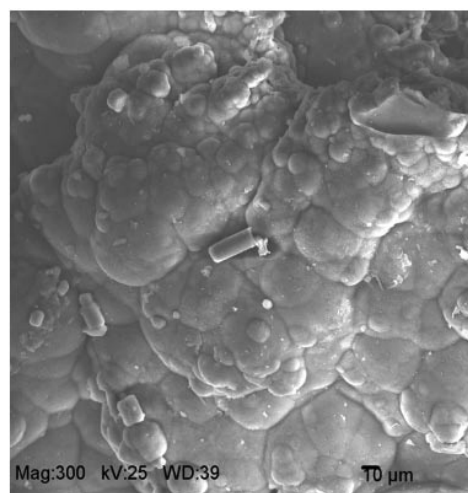
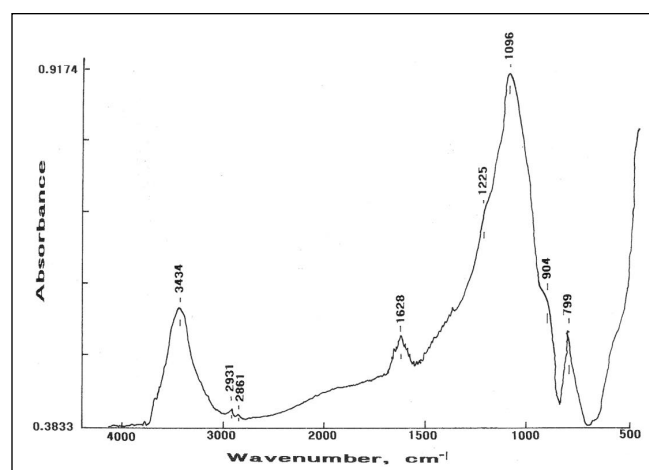
To identify the chemical state of the scales, FT-IR analysis was performed on the 100°C-dried scale powder. The FT-IR spectrum (Figure 3) encompassed eight absorbance bands with assignments as follows (Farmer, 1964): at 3434  $\text{cm}^{-1}$ , revealing the stretching vibration of the hydroxyl (-OH) group and adsorbed moisture; at 2931 and 2861  $\text{cm}^{-1}$ , reflect-

**Figure 3.** SEM microphotograph and FT-IR spectrum for scales deposited on the PPS coating applied to the coupons and carbon steel tubes, and also on the stainless steel tube surfaces after exposure for four weeks at PGV test site.

ing CH stretching vibration in the organic contaminants such oil; at 1628  $\text{cm}^{-1}$ , ascribed to the bending vibration of the H-O-H in adsorbed moisture; at 1225 and 1096  $\text{cm}^{-1}$ , corresponding to stretching mode of the Si-O band; and, at 904 and 799  $\text{cm}^{-1}$ , assigned to the bending vibration of the Si-O-H band. From integrating all these bands, we assumed that the scale is silica gel,  $\text{SiO}_2 \cdot x\text{H}_2\text{O}$ , with some oil contamination. The oil source was probably a petroleum-based corrosion inhibitor applied to the tubes before transport to Hawaii by ocean cargo.

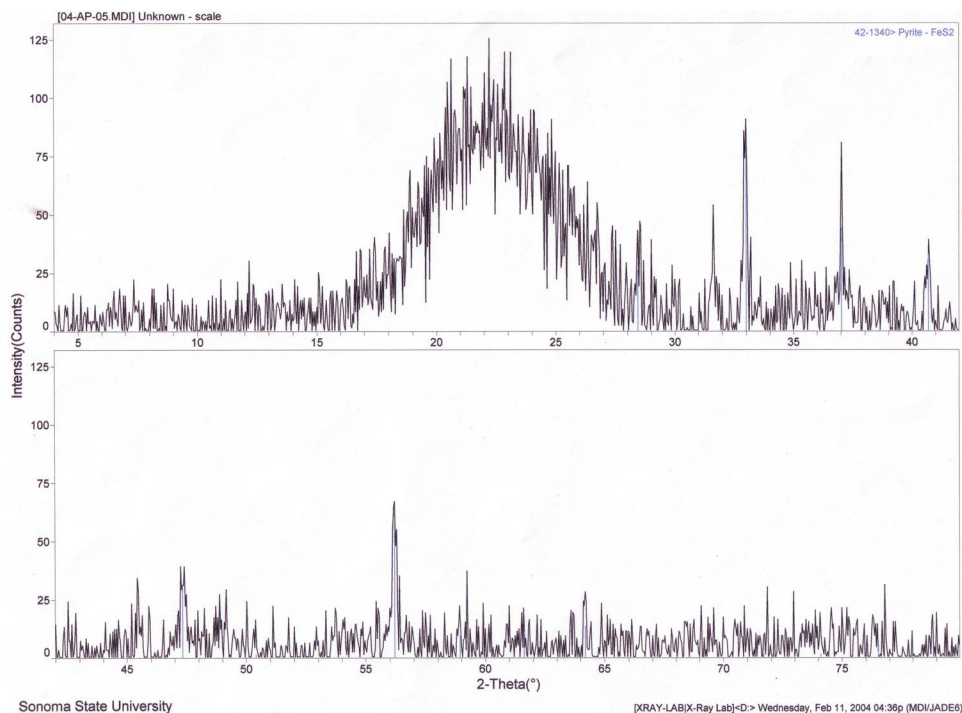
An XRD analysis was performed on the scale from the SS tubes. The XRD spectrum (Figure 4, overleaf) shows the broad diffraction peak centered around 23° (2- $\theta$ ), characteristic of amorphous silica. The only crystalline phase detected in the sample was a trace of pyrite indicated by the 100% peak at 33° (2- $\theta$ ), and lesser peaks at 37.1° and 40.7°. The fact that no other heavy-metal sulfides deposited is significant for the application of a bottoming cycle at Puna, where such deposits have been known to occur and are difficult to treat. Amorphous silica scale, on the other hand, can usually be treated effectively by reducing the pH of the brine (pH-modification).

**Figure 4.** XRD spectrum of scale deposit from SS tube showing predominantly amorphous silica with traces of pyrite.

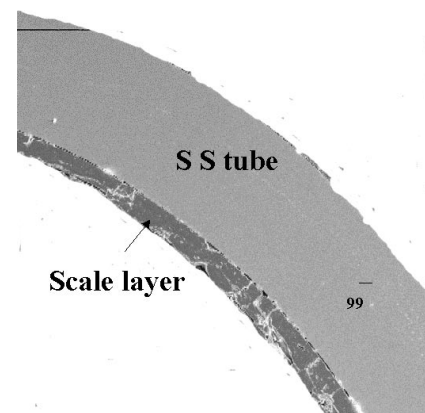
Figure 5 shows the SEM image of a cross-sectional area of a SS tube. Based on the SEM examination, the thickness of scale in this tube was about 8 mils (200  $\mu\text{m}$ ), so that the estimated rate of accumulation of scale was roughly 95 mils/year (2400  $\mu\text{m}/\text{year}$ ). Based on the weight gain for each tube and the scale density, the average thickness and rate of deposition was determined for all SS and CS tubes. The scaling rates for the SS tubes were 63 and 80 mil/yr (1600 and 2030  $\mu\text{m}/\text{year}$ ) for the preheater and vaporizer, respectively. For the CS tubes, the scaling rates were 77 and 117 mil/yr (1960 and 2970  $\mu\text{m}/\text{year}$ ) for the preheater and vaporizer, respectively. The carbon steel surface apparently enhanced the deposition rate of silica over that of stainless steel. This may be due to a greater presence of hydrated iron oxide corrosion products on the carbon steel surface. The tubes in the vaporizer had higher scaling rates than those in the preheater, even though the silica saturation index (S.I.)<sup>1</sup> was much higher in the preheater (S.I. = 2.0 vaporizer., 3.6 preheater). This difference is attributed to the thermal quenching effect on silica scaling kinetics. Rapid quenching of temperature reduces the kinetics of silica deposition and can enable the processing of high silica fluids through heat exchangers (Hirtz, 2000).

The quantity of scale deposited and the reduction in heat transfer after 4 weeks of operation is significant, but not unexpected. In fact, given the high level of silica supersaturation and fairly high salinity of the Puna brine, the results of this untreated baseline test are very promising. The next test at Puna will involve pH-modification, and the use of commercial scale inhibitors.

**Figure 5.** SEM image of massive scale layers deposited on an inner surface of stainless steel tube after only four weeks exposure.

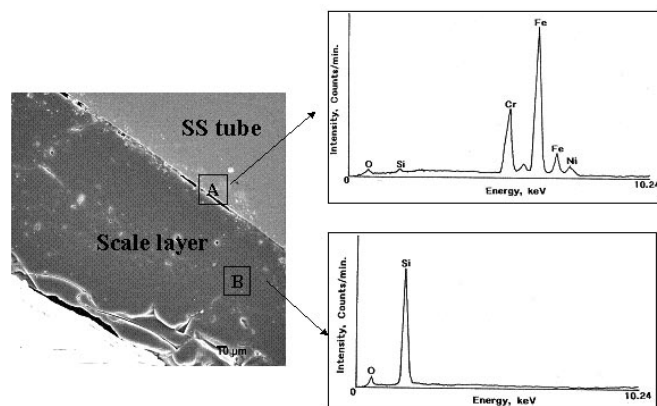
scale layer and stainless steel by SEM coupled with EDX spectra (Figure 6). The SEM image clearly revealed that although there were some interfacial disbondments, the scales adhered well to the stainless steel's surfaces. The EDX spectrum taken from the interfacial area denoted as "A" had five chemical elements, O, Si, Cr, Fe, and Ni. Since the last three elements are associated with the stainless steel, the oxygen element not only comes from the silica, but also may originate from the Cr, Fe, and Ni oxides formed by the oxidation of stainless steel. If this interpretation is valid, the oxide layer occupying the outermost surface sites of the stainless steel may play an undesirable role in promoting its adherence to the silica scale. Further investigation of such interfacial boundary regions may explain the difference in silica scaling rates between carbon steel and other alloy materials.

**Figure 6.** SEM close-examination coupled with EDX spectra at interfacial boundary regions between the scales and the stainless steel tube.

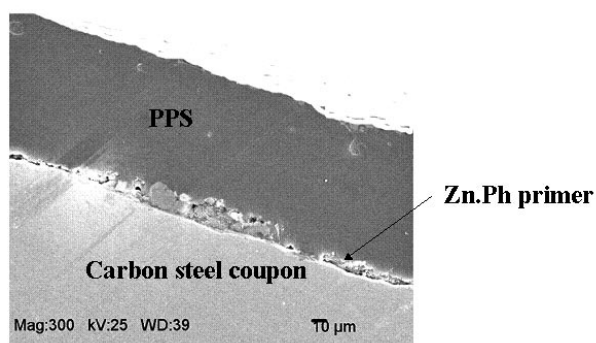
The SEM image of a cross-sectional profile of the four-week-exposed coated coupon clearly verified that the coating remained intact (Figure 7). A close examination of the interfacial boundary region (Figure 8) highlights three distinctive layers: the PPS composite of around 80  $\mu\text{m}$  thick; the zinc phosphate (Zn.Ph) primer of  $\sim 12$  to  $\sim 17$   $\mu\text{m}$  thick; and the carbon steel. Also, there were no signs of delamination of the PPS coating from the Zn.Ph primer layer, as well as no obvious hydrothermal degradation. Thus, we were convinced that the PPS composite withstood hot brine at 200°C and adequately protected the carbon steel against corrosion. The EDX spectrum at the area “A” had three elemental peaks, S, C, and O, attributed to the carbon fiber-reinforced PPS composite. The EDX spectrum of the Zn.Ph primer layer, which acts as a link between the PPS coating and the steel, was characterized by three pronounced peaks related to P, S, and Fe elements, and weak C, O, and Zn signals. Since the S arises from the PPS, it appears that the PPS penetrated into the voids of the crystalline Zn.Ph layer during its melt-flowing process at 300°C and this anchored the PPS within the primer layer. This action of PPS is a very important feature in improving the interfacial bonding between the coating and primer. On the other hand, since the Fe element in the Zn.Ph layer comes from steel, we can assume that the primer layer not only consists of zinc phosphate compounds, but also includes iron phosphate compounds. Further, the incorporation of Fe into the primer layer led to the formation of a primer layer-embedded steel structure, underscoring the strong interfacial bonding between the primer and steel.

**Figure 7.** SEM image of cross-sectional area for carbon fiber-reinforced PPS composite-coated carbon steel coupon after exposure.

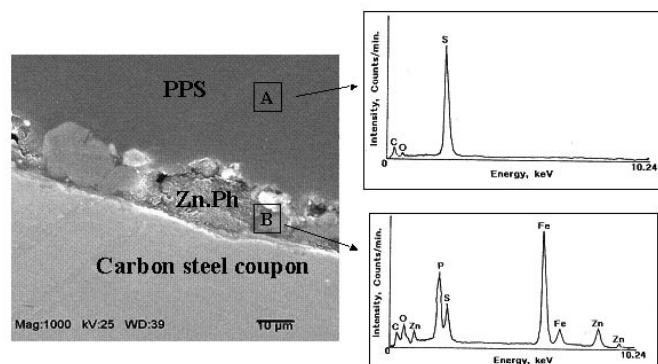
**Figure 8.** SEM image and the accompanying EDX analysis at interfacial boundary region between zinc phosphate-primed steel and PPS composite coating after exposure.

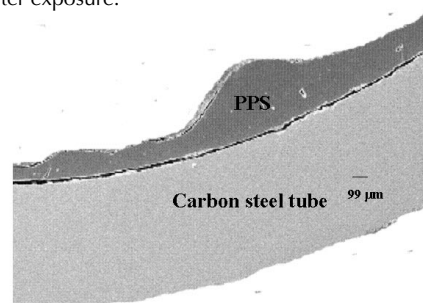
Compared with the SEM image of the PPS composite-coated coupon made by BNL, the composite liner fabricated by Curran International Corp. exhibited a very rough surface, reflecting the liner's thickness, ranging from  $\sim 100$   $\mu\text{m}$  to  $\sim 530$   $\mu\text{m}$  (Figure 9). This thickness was much greater than that of the BNL coating ( $\sim 80$   $\mu\text{m}$ ).

One possible reason for the formation of such rough surfaces was an insufficient drying time for the isopropyl alcohol-based PPS composite slurry layers before the melt-flowing operation at 300°C. If any alcohol remains in the liner when

**Figure 9.** SEM image of cross-sectional profile for PPS composite-lined HX tube fabricated by Curran International Corp., after exposure.

melt flowing takes place, a rough surface texture is frequently created, and, further, the bonds to the underlying tubes become weaker because of the development of a porous microstructure in the composite layers due to the volatilization of the large amount of alcohol remaining in the slurry. To support this concept, we deposited 0.007 in.-thick (0.18 mm) composite liners in 0.5 in. (13 mm) diameter and 2-ft.-long (0.6 m) tubes. These liners were derived from slurries containing 0, 5, 10, 20, 50, and 80% alcohol, respectively, at 572°F (300°C). These composite layers were then subjected to the non-destructive wet sponge holiday test to detect pinholes and voids in the layers. All the liners made from slurries containing more than 20% alcohol failed this test. The wetting agent permeated through the failed liners, which had a rough and porous surface. This finding verified that the alcohol content of the slurry must be no more than 10% before baking it at 572°F (300°C) to produce smooth, non-porous liners. As expected, close examination (Figure 10) revealed that the PPS composite liner had delaminated from the tube's surfaces as one failure mode, and was evidenced in the poor performance of the liner in protecting the heat exchanger tube against corrosion. However, it is uncertain whether this delamination took place before or after the field test. The EDX spectrum at area “B” in the vicinity of the delaminated steel site included two intense peaks associated with the S and Fe elements, and the secondary peaks of C, O, and Zn. No P element was detected, clearly verifying that the tube has no zinc phosphate primer layer. It seems that the tube may have been galvanized before it was lined with PPS because we detected some Zn elements. From

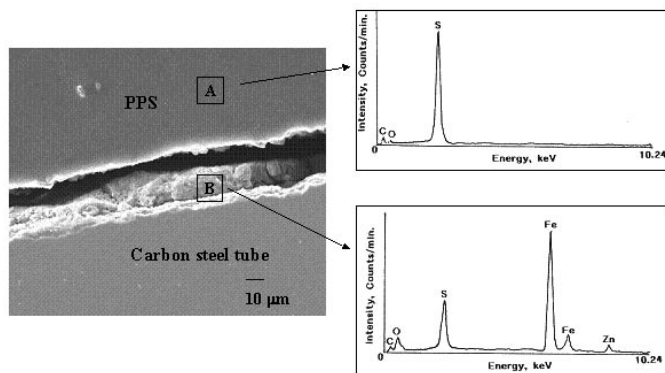
the conspicuous Fe signal in conjunction with the O peak, this delaminated area appears to be occupied by corrosion products, such as iron oxides. However, there were no brine-related elements, such as Na and Cl in this area, seemingly suggesting that the liner did not allow the brine to permeate through it during the four-week-exposure. This finding can be taken as evidence that the PPS composite liner withstood hot brine at  $\sim 200^{\circ}\text{C}$ . Nevertheless, if our interpretation is correct that the primer used in this tube was a galvanized layer, the adherence of PPS liner to galvanized surfaces was poor because of their very smooth texture.

**Figure 10.** SEM image and EDX spectra at interfaces between the heat exchanger tube and PPS composite liner after exposure.
