## San Jacinto—The First Five Years

J. B. Randle<sup>1</sup> and C. T. Ogryzlo<sup>2</sup>

The first 10 MW plant entered production service at San Jacinto in Nicaragua in July 2005. This plant, comprising 2 x 5 MW back pressure steam turbines, was installed as a commercial demonstration plant, and in that role has been a resounding success. Because of caution on the part of investors regarding progressive capital investment in the project and in Nicaragua, a number of features of a long term optimized project were purposely omitted from the initial construction. This paper will discuss the rationale behind the initial development decisions and the subsequent operation of the plant and the reservoir, including improvements that were made to ensure that the plant is now fully capable of delivering its rated capacity, plus a little higher. Some interesting experiences were encountered and some important lessons learned.

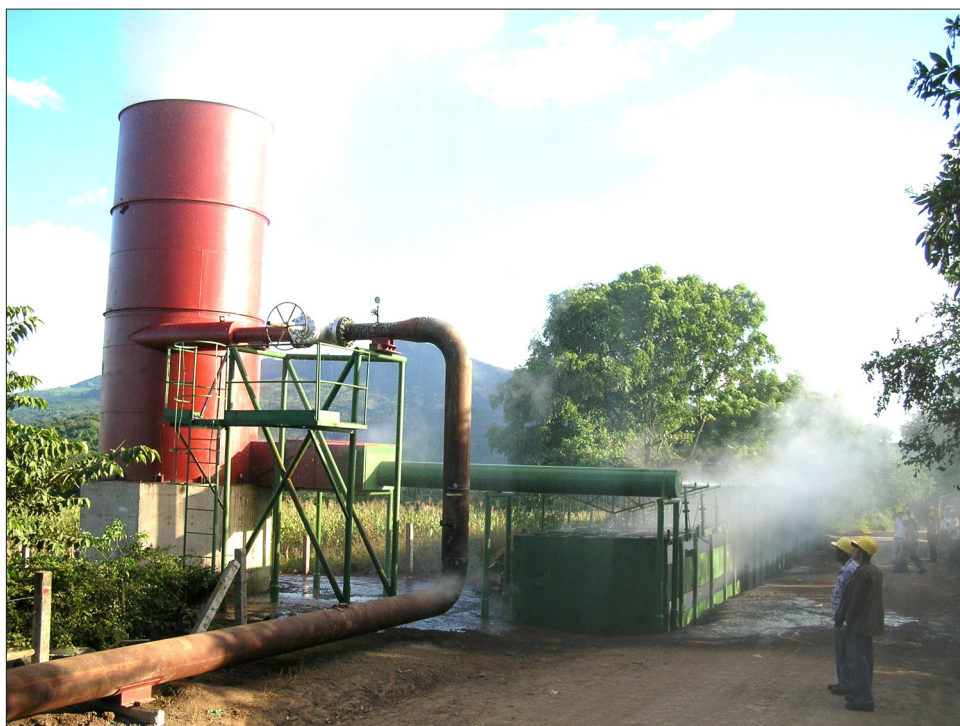
Figure 1. Flash tank and improvised cooling system for cold brine injection.

A simple flash tank was designed and fabricated locally. It was decided, again as a cost saving measure, to use low pressure 18 inch HDPE culvert pipe to transport the atmospheric brine from the flash tank to the injection well, a distance of about 1.3 km. It was recognized that the brine would need to be cooled from 100°C, as the HDPE culvert was not rated to handle that temperature, although tests had indicated that the material would be unlikely to fail by simple softening and collapse. A simple cooling arrangement was fabricated using old mud tanks with overhead distribution pipes made out of irrigation pipe. This system was quite effective in cooling the water from 100°C down to about 80°C.

Unfortunately, the HDPE culvert pipe was found to be unsuitable for the duty. A series of small cracks started to appear quite quickly, which were eventually determined to be due to fatigue failure under a combination of temperature and pressure. Initially, individual sections of pipe were replaced, but in the areas of highest over-pressure these were found to fail again quite quickly. An alternative piping material was obviously required very quickly.

Investigations located a quantity of 16 inch fiber cement pipe, which was immediately available for a very competitive price. This pipe was purchased and laid to replace the HDPE pipe. This material proved to be much more robust and suitable for the duty, and the system continued to operate successfully for a considerable time, despite occasional problems with the acid dosing system.

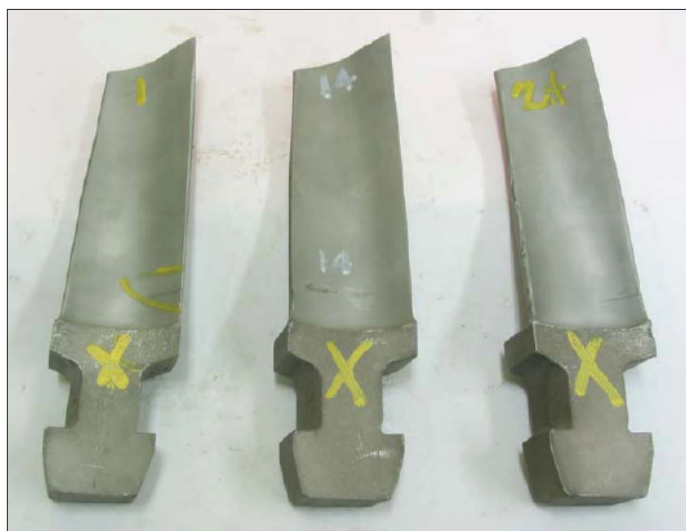
Two problems were however found with the turbines. One unit (Unit #2) was found to have cracking in the fifth row rotor blades. The cracks were all in the same place, a short distance up the blade from the root and running into the body of the blade from the trailing edge. The initial assumption was that this was a blade vibration problem, possibly due to operation close to a resonant frequency.

Figure 2. Cracked fifth row blades from Unit #2.

The entire fifth moving blade row was removed, the rotor re-balanced and the unit brought back into service while a new set of blades could be manufactured and the failure analyzed in more detail. The work was undertaken by Elliott, through their establishment in Guatemala City. Further analysis indicated that the problem was probably due to the unit having been held close to a critical speed during the warm-up process. The plant has suffered from numerous trips due to trips of the Nicaraguan national grid (very seasonal, due to lightning strikes during the rainy season and sometimes to other flash-overs during cane cutting season), during which the unit governors and overspeed protection have been unable to handle a full load rejection. The operators were in the habit of adopting a normal, cold restart procedure even when restarting following a very brief grid outage, and as such the unit had spent more time than would normally have been expected close to the critical speed (Unit #1 sits at a

slightly different speed when warming up, the hold point being established by the manufacturer by the degree of opening of the start-up valve, not the actual rotor speed). The fifth row blades have recently been replaced, a hot restart procedure has been developed to remove the requirement for holding the unit at a lower than normal speed, the normal start procedure has been modified to take the holding point away from the critical point and the unit is now operating well.

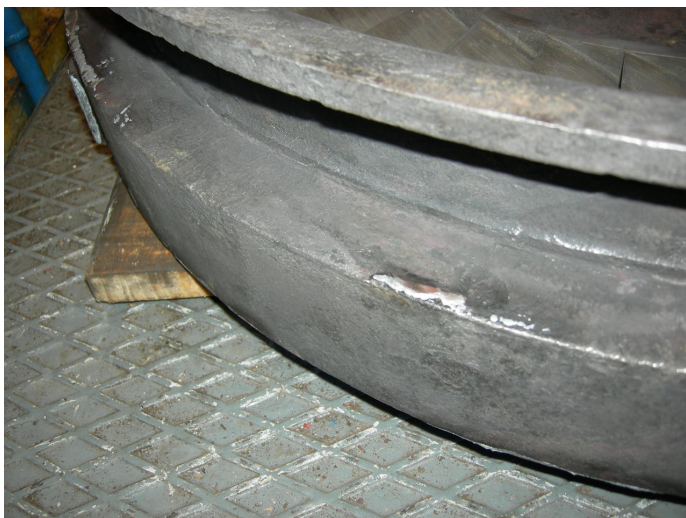
The second problem identified was with erosion in the diaphragm seating area. The diaphragms sit loosely in a groove in the casing and are held in place by the steam pressure across the diaphragm, which presses the diaphragm against a plain metal seating. At some time in the past, someone had tried to adjust the axial position of some of the diaphragms and had done this by building small patches of weld metal on the downstream diaphragm face. Unfortunately, this was on the supposed sealing face of the diaphragm and had the effect of preventing the diaphragm from seating fully and hence from sealing the steam across the diaphragm.

**Figure 3.** Diaphragm showing weld metal on the sealing face used to reposition the diaphragm axially.

The result was excessive erosion of the seating and sealing face, both of the diaphragm itself and also of the casing. The diaphragms could be welded and machined locally to restore the sealing face, but it was not possible to do this with the casing. A temporary repair has been carried out using Belzona to smooth out the seating in the casing – an inspection is planned for later this year to assess how this repair is surviving.

It is intended that both of the back pressure units will be withdrawn from service following the completion of the current project expansion program in December 2011 (installation of 2 x 38.5 MW condensing units) and so the current repair of the diaphragm erosion problem is only required to provide a temporary solution. Once the units are withdrawn from service, if they are required to be relocated to another project then it will be necessary to return the casings to a service shop that has the facilities to weld repair and re-machine the diaphragm seating grooves.
