Simulated Down-hole Casing Corrosion Protection Tests by Addition of Filming Amine Products into Geothermal Injectate at The Geysers

Allen Sonnevile, Brian Benn, and Tim Conant
Calpine Geysers Power Plant, Middletown, CA

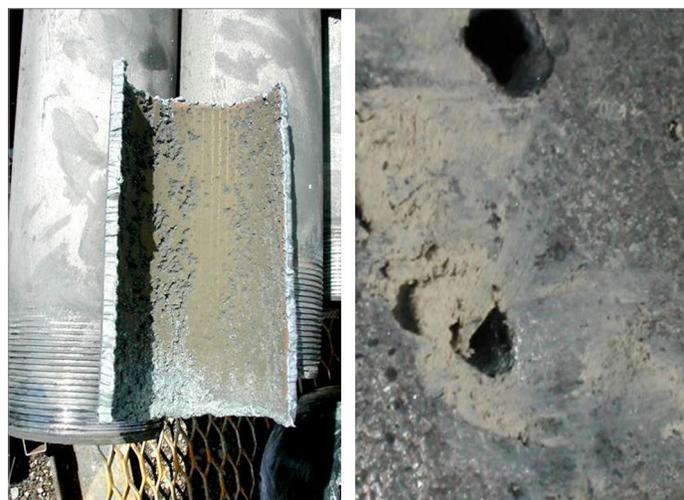
1. The Barrows 7 injector failed due to pitting corrosion from oxygen attack despite continuous corrosion inhibitor additions to the injection water (Figure 2).

Figure 2. Barrows 7 Injection Liner Oxygen Pitting Corrosion.

Barrows 7, relatively cool oxygen saturated injectate water falling from the surface into the injection well was heated in the steam entry zone, causing the accompanying pitting corrosion (Figure 2). Although filming amine corrosion inhibitor accompanied the injectate water, and surface corrosion monitoring indicated that inhibitor dosing was adequate, the heat resulting from former steam entries on the outside of the injection casing defeated the protective amine film on the pipe wall and allowed corrosion to proceed. Similarly, at CMHC2, generalized corrosion occurred in the heated zone when acidic injectate corrosion was accelerated in the heated area. pH drop due to chemical and biological aging of injectate water from a Burner H₂S abatement equipped plant can result in acidic water with a pH of 2.5. This low pH can neutralize the amine portion of the inhibitor and result in generalized corrosion of the casing, unless the neutralized inhibitor is continuously replaced with fresh inhibitor. Injectate water at The Geysers falls under vacuum from the surface, which can result in scouring off of the filming amine inhibitor at depth as the directional change occurs in the well. Again, the remedy is to continuously replace the amine layer by adequate dosing.

The remedy in the case of Barrows 7 and other injection wells was to double the inhibitor dosage rate and run calipers to determine if the dosage was adequate. This was not only expensive but it did not solve the problem of determining the most effective and economical dosage rate. To that end, Calpine constructed a test skid to simulate down-hole injection conditions, and determine dose rate and efficacy of inhibitor products.

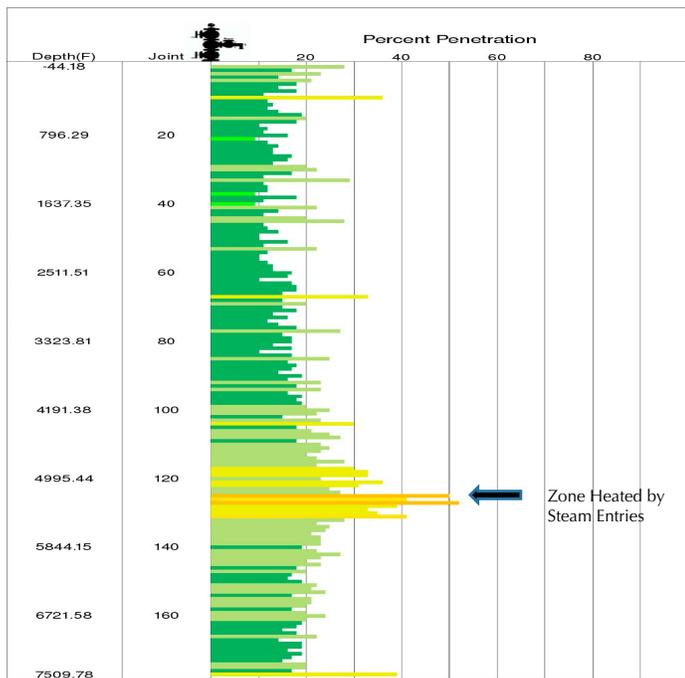
2. Acidic injectate in CMHC2 from a Burner H₂S abatement equipped plant resulted in >50% wall loss over a one year period. See well caliper log (Figure 3).

Figure 3. Generalized Corrosion from Acidic Injectate: CMHC Casing Penetration vs Depth.

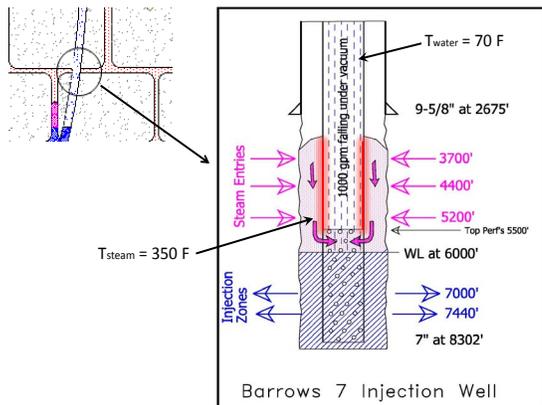
In both cases the injection well casing corrosion occurred where the injection liner had penetrated a former steam entry (Figure 4).

Heating of the exterior of the casing results in loss of the filming amine barrier and accelerated corrosion attack. In the case of

Figure 4. Injectate dissolved O₂ attacks unprotected casing.

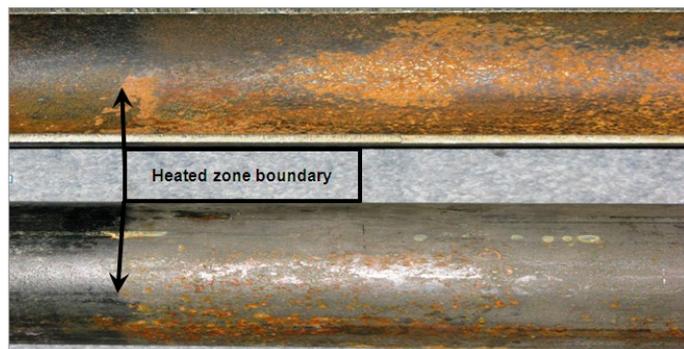
Photo 1a and 1b. Corrosion Coupon Pipe Nipple Sliced Lengthwise.

long curved coupons were lightly bead blasted before acid cleaning. The results of that trial can be found in Table 1. (The names of the suppliers have been withheld). An example of one of the corrosion coupon pipe nipples is shown in Photo 1.

The untreated control test loop had the highest corrosion rates and showed pitting in the pipe section inside the steam jackets. All of the amine treated loops showed less corrosion than the control. The long curved coupons were more difficult to evaluate due to the length and curvature making bead blasting difficult and due to exterior corrosion caused by the ambient environment at The Geysers. This external pipe corrosion affected the weight loss after cleaning and inflated the corrosion rate. Regardless of whether those curved coupons are included in the average calculation, the product from Supplier #4 performed the best with Supplier #1 a close second. The difference in corrosion rates among Suppliers on average was not large, so the treatment cost differentiated the winners. The test skid results enabled the Geysers to select treatment suppliers not only on performance but cost as well, resulting in a savings of approximately 50% compared to previous the Geysers filming amine treatment cost.
