Maintenance of Olkaria 1 Additional Units (AU) Power Plant, Kenya

George Ngomi

Kenya Electricity Generating Company

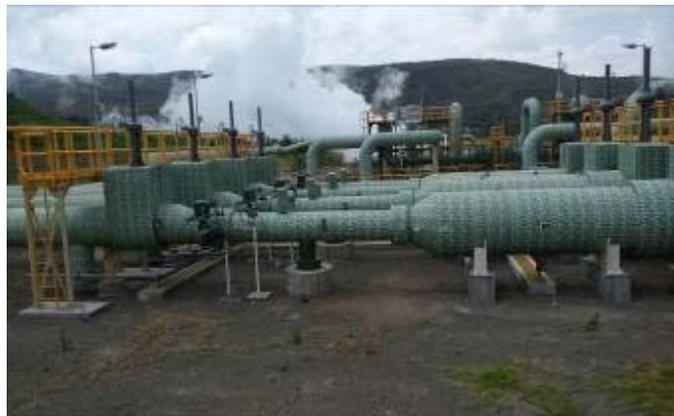
Figure 5: Pressure control valves

Prior to installation of this station, the wellhead pressures ranged from 6 to 9 barg while the separation pressures were 5.5 barg to give a turbine inlet pressure of 4.2 barg. After installation, the wellhead pressures ranged between 10 to 14 barg while the separation pressures are 10 barg to give a turbine inlet pressure of 4.2 barg. The station has special pressure control valves that carry out adiabatic expansion of the steam and maintain a high upstream steam field pressure and the desired downstream pressure at the plant. Maintenance is mainly carried out on blocked pressure control valves which are Fisher and Rotork type. The blocking is mainly due to fouling by silica from the production well and not a valve defect.

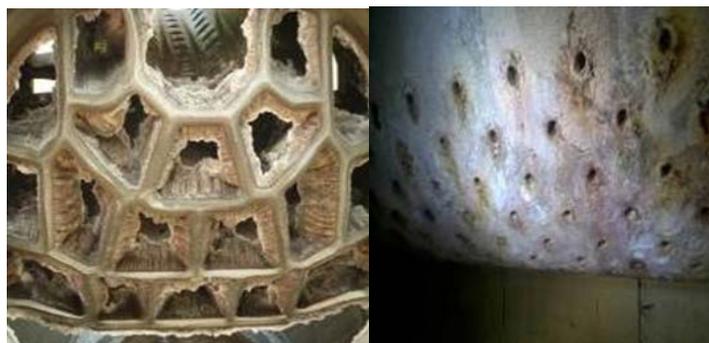
Figure 6: Clogged vent valves and diffuser at the vent station

The vent valves are ball butterfly (Fisher) type and are designed to handle a total of 1046 T/hr of steam. Maintenance at this station is mainly carried out on the valves, condensate drain ports and diffusers. The valves are stroked and calibrated while condensate drain ports and diffusers unblocked and cleaned. The Figure 6 below shows pictures of a clogged flow control valve and diffuser.

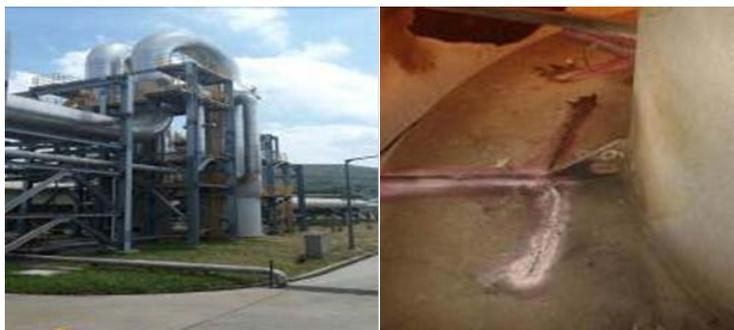
Figure 7: Steam scrubbers and internal repairs done by EPC contractor

The steam scrubbers provide 99.98% dry steam to the turbine. They are cyclonic separator type and have less than 0.1 barg pressure drop at rated conditions. They are equipped with a waste condensate vessel where the condensate separated is collected temporarily before being discharged to the cooling tower through spargers. The discharge is enabled by drain valves. Carryover from the separators due to an unreceptive hot reinjection well led to frequent clogging of these drain valves thus initiating turbine trips due to high condensate levels in the scrubber. Scale pellets were cleaned from the drain valves. In November 2014, Unit 4 and Unit 5 scrubbers experienced unusual reverberations. Inspection revealed that the vortex tube and smoothing sleeve weld seam had failed and repair was done. However, this did not last as after about six months of operation, the defect reoccurred. Further analysis showed this was as a result of a poor weld detail implemented as part of the first repair. A comprehensive repair methodology was adopted and the scrubbers returned to service.

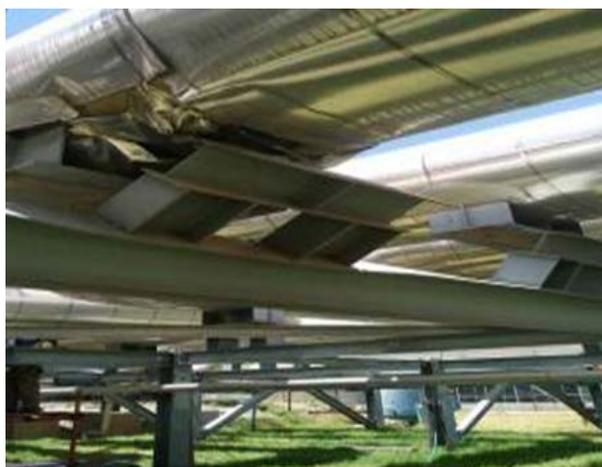
Figure 8: Deflected main steam line due to slug flow

Slug flow is intermittent flow caused by a moving liquid bubble mass being pushed by a gaseous mass. In March 2016, this phenomenon occurred in Unit 4 resulting in deflection of steam line support structures as shown in Figure 8. The damaged structures were repaired and reinforced. To avoid such scenarios in future, it was resolved that frequent monitoring of clogged steam drains must be undertaken so as to unblock them before starting up the plant.

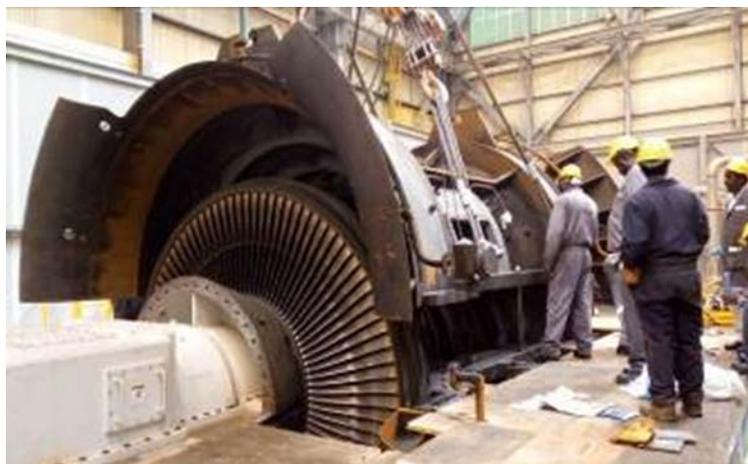
Figure 9: Steam turbine overhaul during an annual inspection

This turbine is a tandem-compound single cylinder double flow exhaust type as shown in Figure 9. The turbine has two (2) by seven (7) stage blade. The rated power output of one unit is 75.26MW at the conditions of 4.8 bar abs/150.3°C steam for IP steam and 1.14 bar abs/103.3°C steam for LP steam. The turbine has supervisory and monitoring instruments for temperature, speed, eccentricity, differential expansion and vibration thus enhancing condition based monitoring and maintenance.

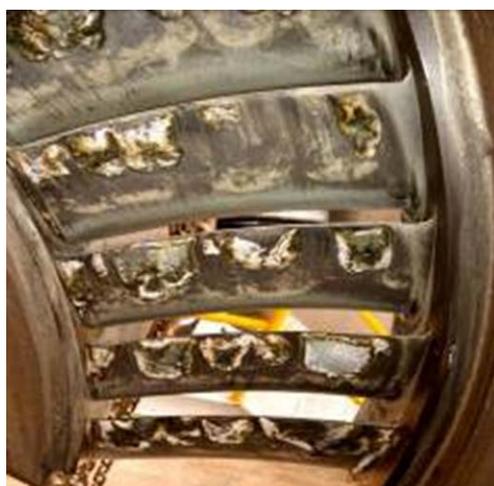
Figure 10: 1st stage stationary nozzle silica scaling

During commissioning, steam pressure drops between the 1st and 2nd stage steam turbine nozzles were experienced leading to onsite nozzle clearance enlargement by Toshiba. At end of defect liability inspection, the turbine was disassembled and scaling found in the 1st stage nozzles as shown in Figure 10. This was attributed to the unreceptive hot reinjection Well 13 leading to carry over from the separators into the plant. The scaling was cleaned and the turbine reassembled.

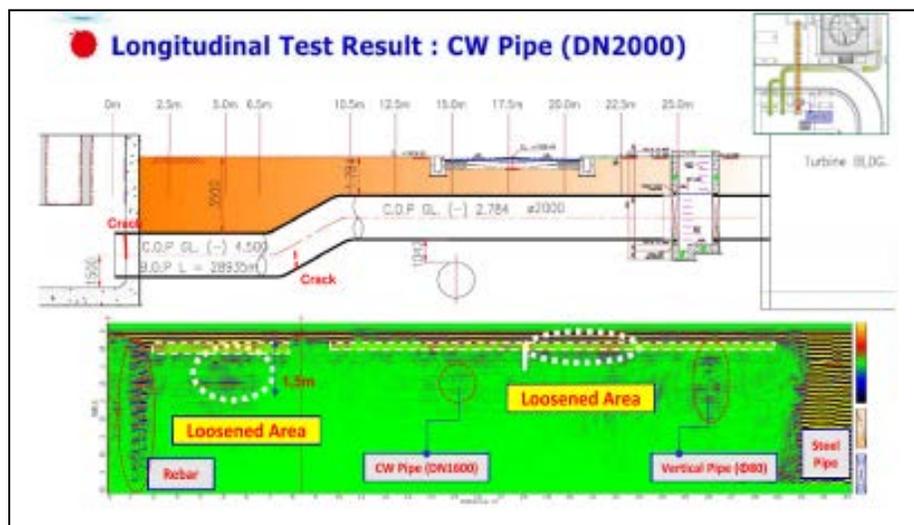
Figure 12: GRP longitudinal test results

The GRP pipe sand bedding was washed out causing pipe differential settlement. To ascertain the effect of the leakage on the general area, Geophysical surveys, ground penetration and electrical resistivity tests were done as shown in Figure 12. These tests confirmed poor consolidation as a result of the water ingress and grout injection was the available remedy for reinforcement of the sand bedding of pipe and the general area. This was done using low pressurized mortar. KenGen is considering encasing the GRP pipes in concrete and in other areas, using stainless steel pipes in ducts.
