Casing Failures in High Temperature Wells

Kristinn Ingason, Arnar Bjarki Árnason

Mannvit Engineering Ltd

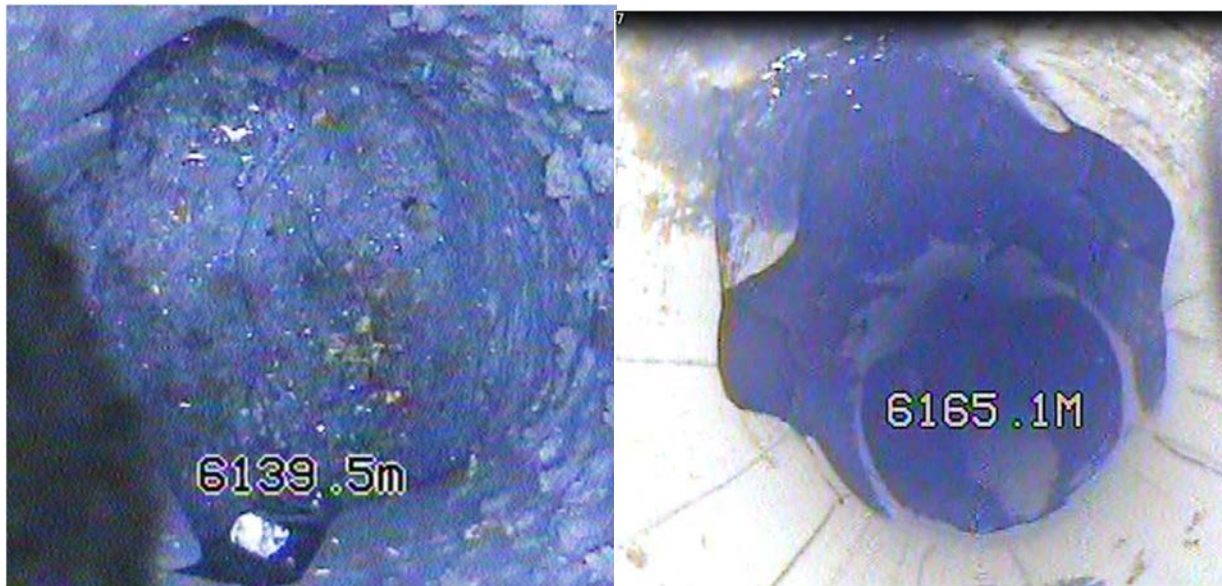
Cementing the innermost casing, $\phi 9\text{-}5/8''$, was challenging and water was most likely entrapped between the $\phi 9\text{-}5/8''$ production casing and $\phi 13\text{-}3/8''$ anchor casing at the intersections between two cementing operations at about 610 m. This water caused a collapse of the $\phi 9\text{-}5/8''$ casing already in the initial flow test as the well was successfully logged to bottom on March 15, 2010, but the logging tools stopped roughly at 620 m when logging March 24. The discharging of the well started March 22. This damage did though not prevent the well from discharging and during the flow test the flow from the well was up to 50 kg/s of fluid with enthalpy close to 3200 kJ/kg. Temperature of up to 440 °C was measured at wellhead during the flow test.

Pictures from the damage at 610 m are shown in Figure 1. Several meters of the $\phi 9-5/8''$ casing had fully collapsed, and the steam had flown in the annulus between the $\phi 9-5/8''$ and $\phi 13-3/8''$ casings in this interval. This flow restriction was not observed when the well was discharged and as there were three casing strings in the well at this depth, this failure did not compromise the integrity of the well.

Figure 1: IDDP-1, damages at 610 m depth before and after drilling through the damage

A fault in the cementing in IDDP-1 caused collapse and other casing damages at 610 m depth. These damages were observed during the heating up of the well, when a logging tool could no longer be run below this depth. After the quenching these damages could be inspected and the innermost $\varnothing 9\text{-}5/8$ " casing turned out to be badly damaged as can be seen in Figure 2. These damages did though not give problems during the discharging of the well. Neither was the well integrity compromised as there were two casing strings outside the $\varnothing 9\text{-}5/8$ " casing at this depth, i.e. $\varnothing 13\text{-}3/8$ " and $\varnothing 18\text{-}5/8$ ".

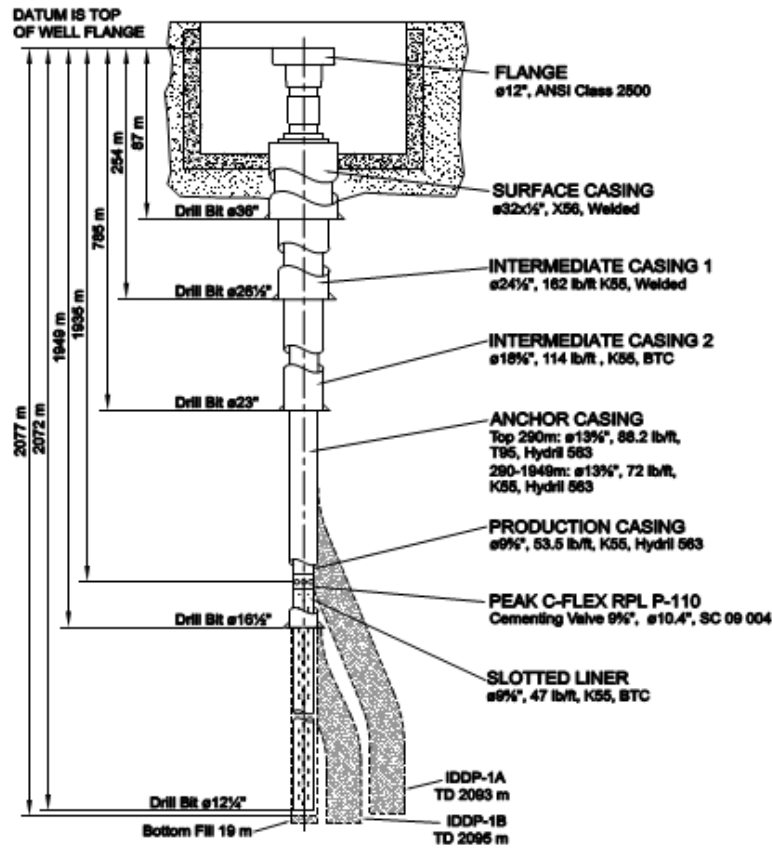
Figure 2: IDDP-1 as-built

IDDP-1, the first of the three IDDP wells planned, was drilled in the Krafla Geothermal Field in 2008–2009 by Landsvirkjun, the National Power Company of Iceland. The well was designed to reach supercritical conditions at 4500 m, temperatures above 374 °C and pressures above 22 MPa. Drilling progress was as planned down to around 2000 m when drilling became quite challenging, including becoming stuck at 2094 and 2095 m depth, followed by twist offs and subsequent side tracking. Finally, drilling came to an end at 2096 m depth in the third leg when cuttings of fresh glass indicated the presence of a magma body at the bottom. An as-built drawing of the well is presented in Figure 2.

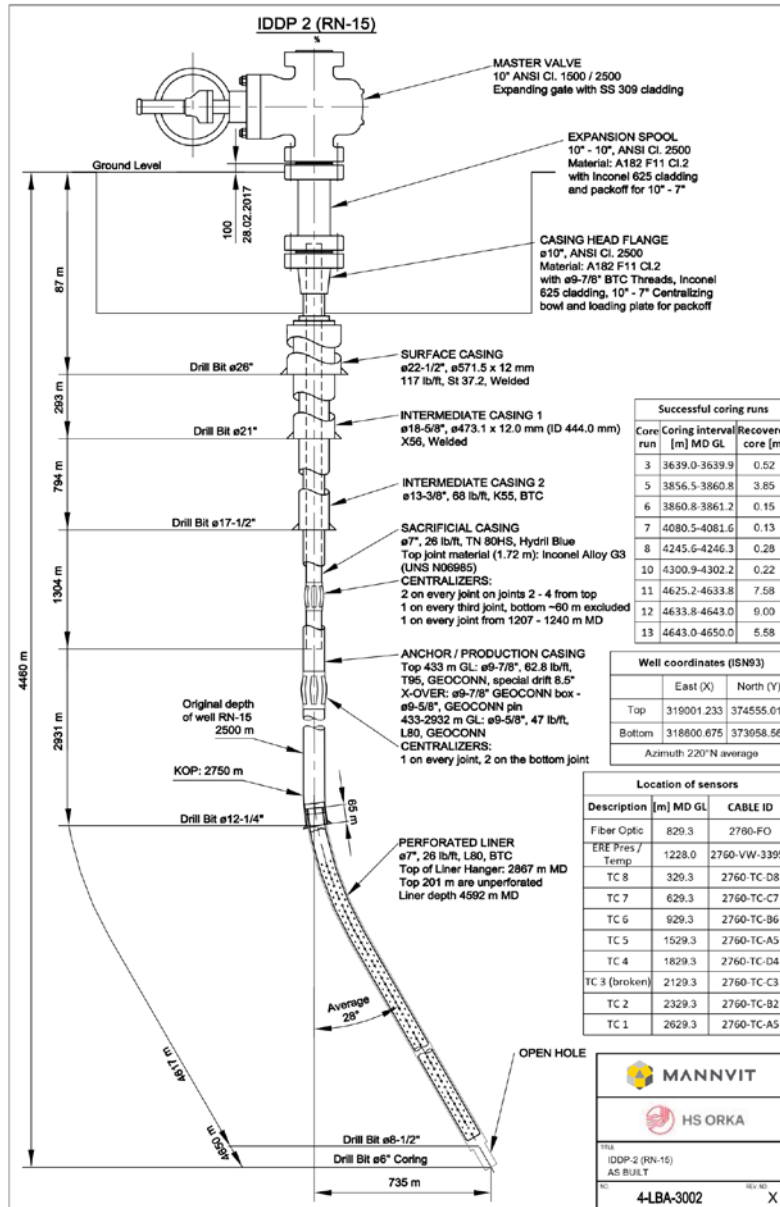
Figure 3: IDDP-2, as built

The drilling of the second IDDP well, IDDP-2, was completed in January 2017. A 2500 m deep well, RN-15, was deepened to depth of 4650 m and thus making it the deepest high-temperature well in Iceland. An as-built drawing of the well is presented in Figure 3.

A $\phi 9\text{-}5/8"$ casing was run from surface, through the original production section of the well, down to 2930 m depth and cemented using reverse cementing method. Cement bond logging (CBL) and temperature logging after the casing had been cemented indicated poor or no cement at an interval of 100 m or more below 2.3 km depth. The reason for this is likely use of retarder in the cement slurry in the bottom part of the well but not in the upper part. Casing failure was later observed in this interval. At that time the casing had gone through temperature cycles, though relatively moderate and maximum temperature unlikely to have been higher than 200 °C.

The cause of the casing failure in IDDP-2 is different from other failures discussed and described above. The most likely reason is a long, probably more than 100 m, uncemented casing below 2300 m depth and even though the temperature changes were relatively moderate, it was enough to cause the damage. The root cause was the cementing.

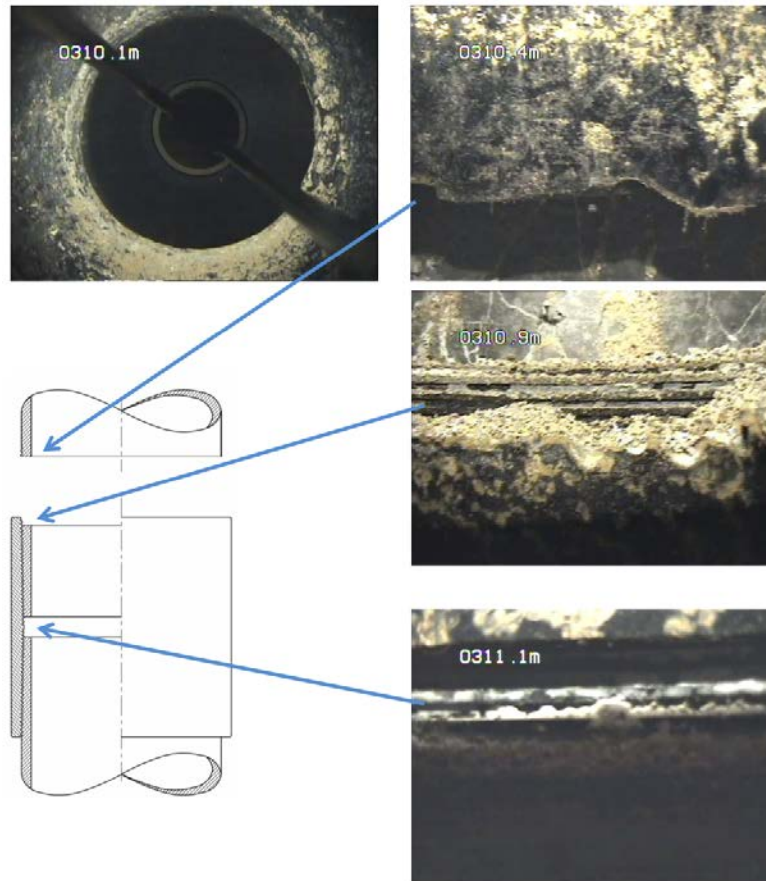
The leakage was developing into a serious blowout and decision was made to pump cement down the hole. This was successful and later, after the top part of the cement had been drilled, the casing was inspected using a video camera. The casing was broken in two places, at 130 m depth where the pin broke at a lower end of a coupling creating a gap of 300 – 400 mm and 303 m depth where the pin broke at the upper end of coupling creating a gap of 500 – 600 mm. Pictures of the damage at 303 m depth are shown in Figure 4.

Figure 4: HE-53, damages of the $\phi 9-5/8''$ production casing at 303 m depth

The history of HE-53 in Hellisheidi, Iceland, and OW-740A in Olkaria, Kenya, are similar. In both cases leakages were discovered in the production casings just below the anchor casing shoe after the wells were shut-in following initial discharge tests. It is difficult to confirm the reason for the damages, but poor cementing is likely to play a role. The anchor casing shoe may also add to the load on the production casing. OW-740A was successfully quenched using water but cement was needed to kill HE-53. Inspection of the wells, after they had been quenched, revealed the production casings had in both wells broken at 130 – 190 m depth. Given the operational history of the wells, those damages are most likely caused by the quenching or an attempt to quench.

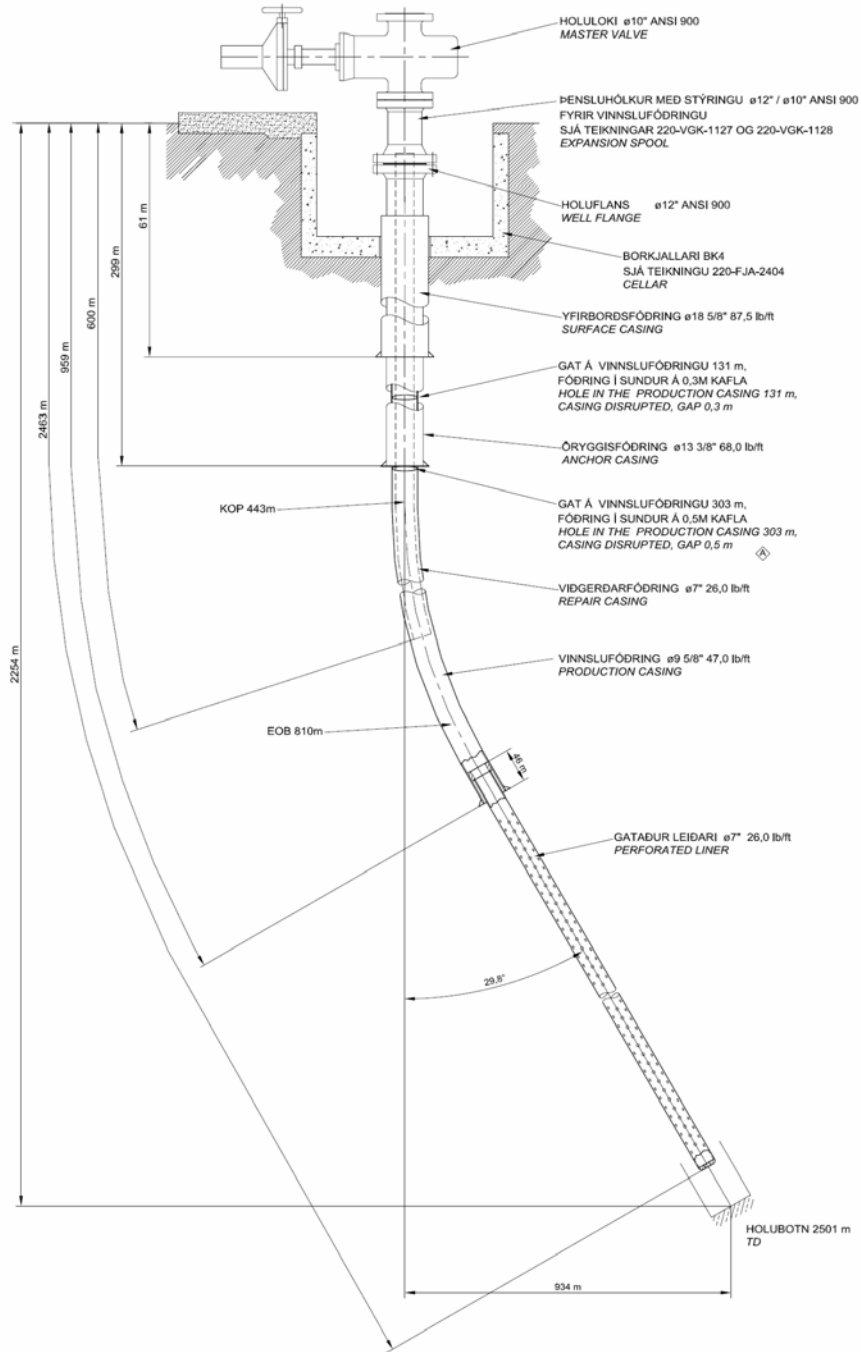
Figure 5: HE-53 after repair

A $\phi 7''$ liner was run and cemented in the well covering the damaged parts. Figure 5 shows the well after repair. The well has been producing for the past years though at lower output than originally measured.
