## Improved Efficiency of Solid Trap in Brine Injection Pipeline of Tongonan Geothermal Field, Leyte, Philippines

R. R. Villa, Jr., H. L. Isip, J. R. S. Peñaranda, J. P. Villena, U. R. P. Bontia and E. H. Alcober

PNOC Energy Development Corporation  
 PNPC Complex, Merritt Road, Fort Bonifacio, Makati City, Philippines

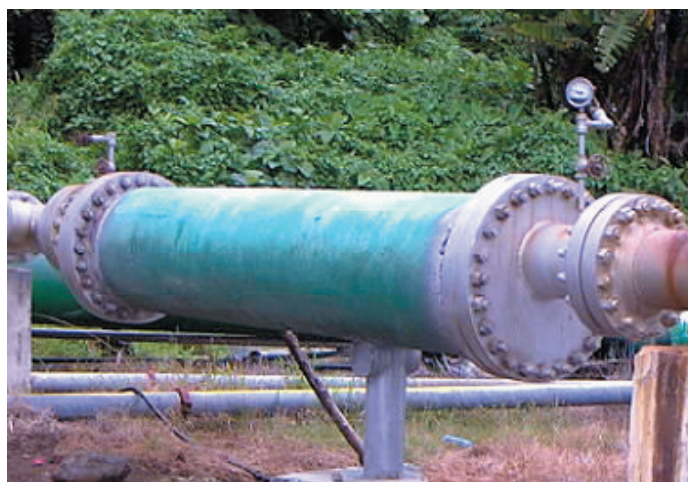
Figure 2. The original 1R8D solid trap.

The original solid trap installed in 1R8D is a single 20-inch diameter pipe around 6 m in length (Figure 2). Due to minute size of the solids captured by the brine and the high velocity (Reynold's number = 4500) of the brine flowing along the brine line, this solid trap was proven ineffective because when it was opened, only a small amount of solids were collected. This was contrary to the observation upstream in the separator and flash vessels, that significant amount of solids were removed by washing the steam with brine.

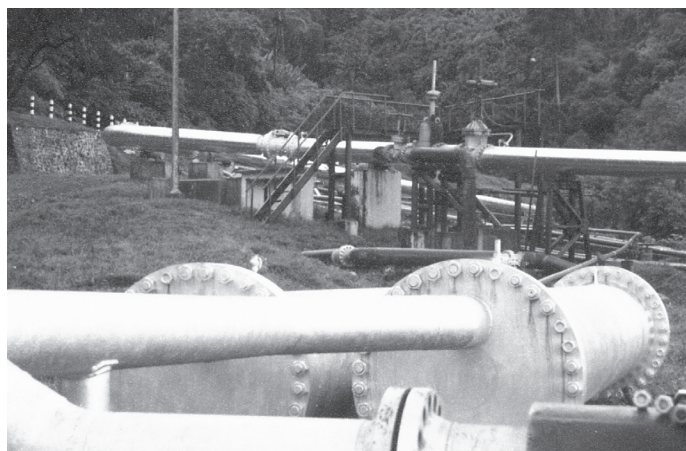
The characteristic of the solids captured by the wash fluid is that it has a minute sandy texture and particulate size that tends to be lighter and remains suspended in the brine if the velocity is high enough to carry it. But if the velocity is significantly reduced, then the solids will have enough time to settle down. This was noted from the solids deposition mechanism at the bottom of the LCV valve seats and at FV-100 brine drum. The modified solid trap was designed to significantly reduce the brine velocity. It allowed and gave sufficient time for the captured solids to settle down before the brine exits the solid trap and injected into the well. It consists of two Class G 36-inch pipe by 7.5 m length installed parallel to each other (Figure 3-4). From the main reinjection line, the flow in the

Figure 3. The new modified solid trap at 1R8D.

10-inch brineline is divided by a bifurcator before it enters the two solid traps. To recover the original velocity of the brine, the exiting brine flows (after most of the solids have been removed) were joined again by another bifurcator, then injected to 1R8D. The velocity of the brine inside the solid trap is significantly reduced due to the increase in the diameter of the pipe from 10-inch to 36-inch and since the total flow has been bifurcated into two. Furthermore, double baffle plates were installed inside the solid trap (Figure 4) to serve two purposes: (1) to reduce further the velocity of both brine and solids inside the large diameter pipe (Reynold's number = 1200); and (2) deflect the settling solids at the bottom of the slow moving brine allowing only the cleaner upper portion layer to overflow to the next chamber. The outlet of the solid trap was located near the top to allow the solids carried to the second chamber to settle further and allow the upper layer brine that is relatively free of solids to pass through.

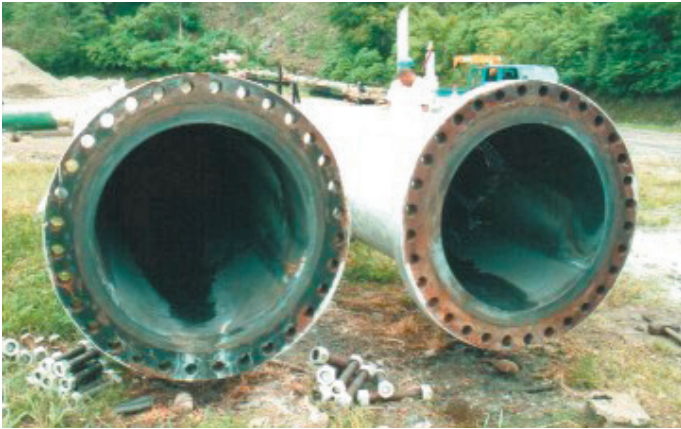
Figure 6. 1R8D modified solid trap inlet.

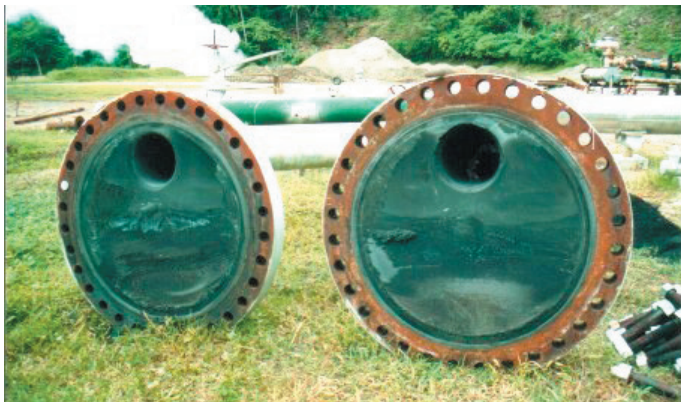
Figure 8. Modified solid trap outlet flanges.

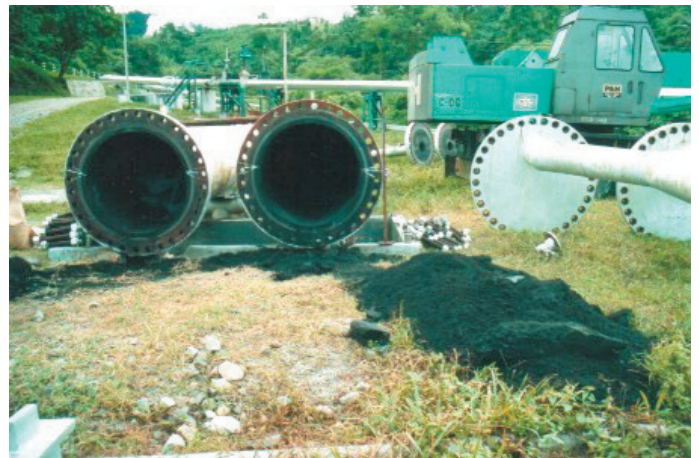
The samples of solids taken from inside the 1R8D modified solid trap was sent to Petrolab for Petrologic analysis. Presented in Table 2 are the results of the megascopic and petrologic analyses of the samples. Note that from the analysis of the samples, it is shown that these are composed of polymerized silica (50%), corrosion products (40%) consisting of magnetite and hematite, and formation materials (10%). These corrosion products are those that were removed from the steam after washing it with brine at the main two-phase line. These solids were flushed out from the separator and flowed through the brineline.

Figure 10. Solid debris taken from the MST.

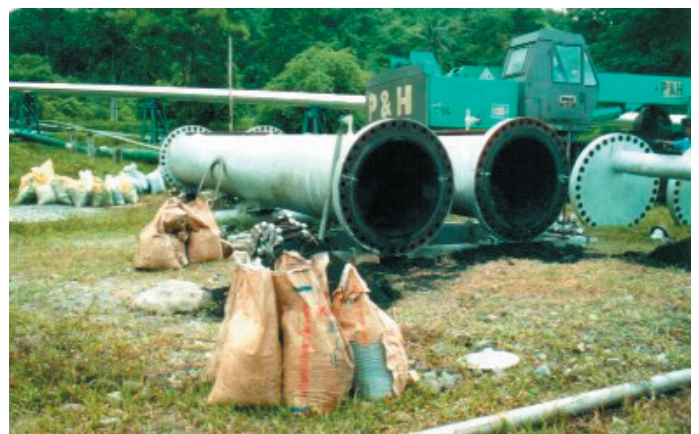
Figure 11. Solids debris collected from the MST.

since the utilization of the solid trap until it was opened was only 167 days from commissioning. With the 3,445 kgs of solids collected, this translates to at least 20.6 kg/day of solids that were captured by the solid trap. If this amount were not

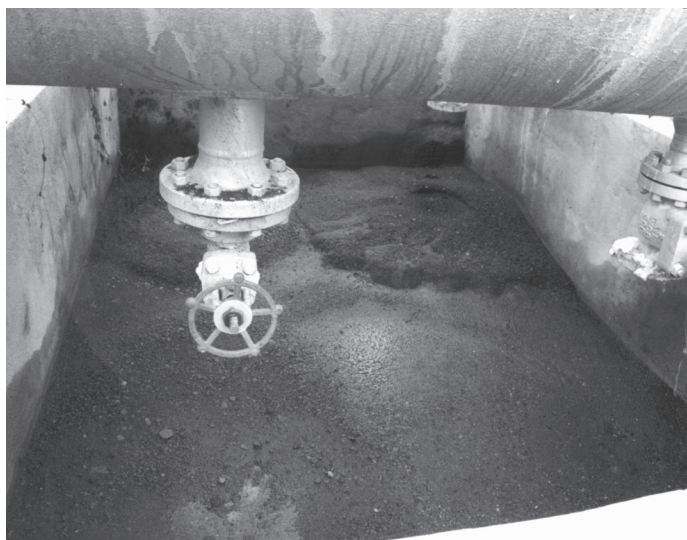
Figure 12. Debris found at the MST drain box.

However, based on observation during inspection there is a limit in the capacity of the modified solid trap to capture the solids. Its efficiency would be reduced when the solids would start to build-up and begin filling-up the chambers near the baffle plates at the end section of the solid trap. It is thus proper to prevent the captured solids from accumulating inside the solid trap through regular draining of the drains installed near the baffle plates. Also, bi-annual inspection and cleaning should be conducted.
