Simulated Down-hole Casing Corrosion Protection Tests by Addition of Filming Amine Products into Geothermal Injectate at The Geysers

Allen Sonnevile, Brian Benn, and Tim Conant
Calpine Geysers Power Plant, Middletown, CA

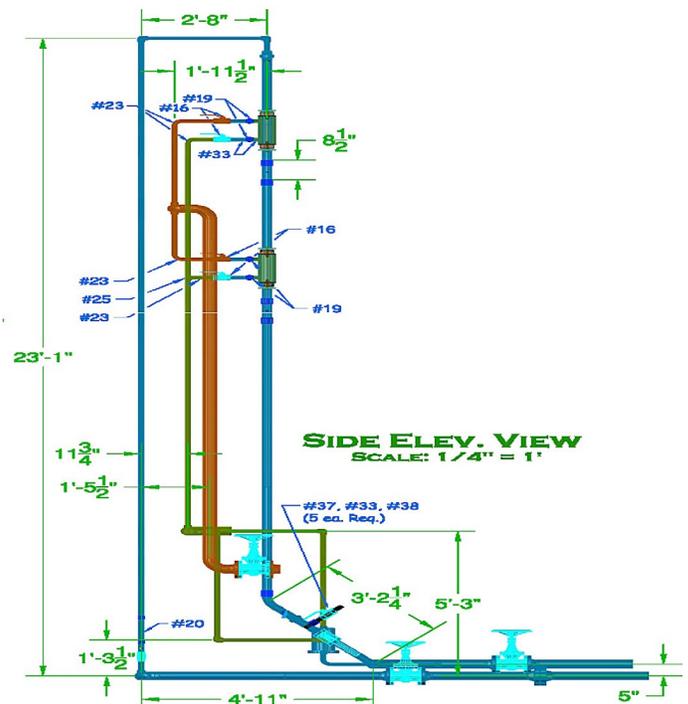
Figure 5.

The skid consists of four parallel runs of two vertically oriented single pass shell and tube heat exchangers. Injectate water is passed "tube side" through pre-weighed pipe nipples which act

as a corrosion “coupons”. Steam is added “shell side” to heat the outer wall of the pipe nipple/coupon thus simulating an injection casing penetrating a former steam entry in the reservoir. Corrosion inhibitor (filming amine) is added to the injectate water before passing through a static mixer which ensures adequate mixing as it rises 23 feet to the top of the test loop. At the top of the skid just when the water starts to fall, a specifically designed nozzle is located to throw the water towards the pipe wall for a more uniform treatment. Injectate corrosivity is measured with a corrotor and a traditional in situ corrosion coupon as the heated water leaves the bottom of the skid. As shown on the side view schematic (Figure 5), two steam jackets are located in line on each test loop to raise the surface temperature of the pipe wall and to elevate water temperatures by several degrees.

Two of the pipe nipple coupons are located below each of the steam jacket and a third long curving pipe nipple coupon is located at the bottom of the test loop. The pipe nipple sections inside the steam jackets can also serve as coupons and be evaluated for corrosion. A corrotor probe measures the relative corrosion rate at the outlet of each test loop to provide real time indication on the treatment effectiveness for dosage adjustments. Also on the outlet is a temperature sensor for each test loop to give indication of a corrosion breach inside the steam jackets where steam can flow into the testing solutions. When steam breaks through the temperature rises dramatically. The waters of each test loop are then recombined and returned to the injection well downstream of the well’s flow control valve. Since the injection well is on vacuum those same pressures are propagated to the downward leg of the test loop simulating down-hole conditions.

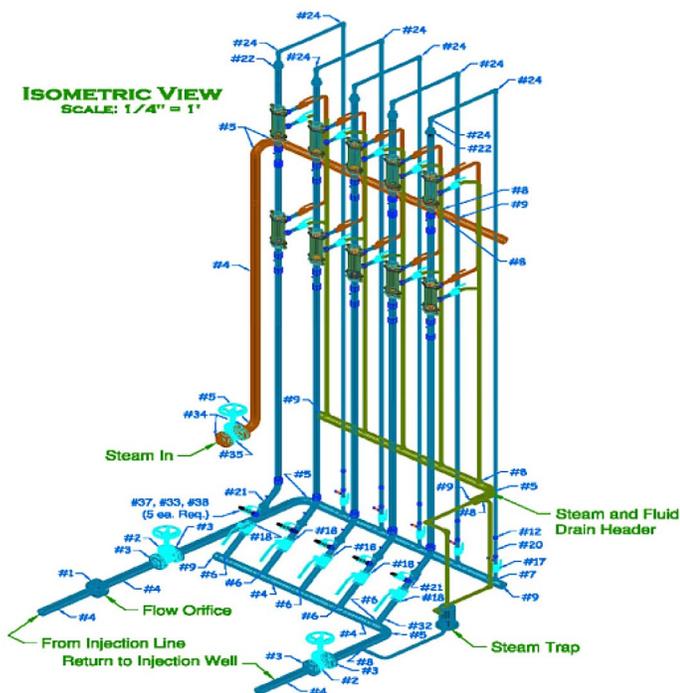
Figure 6.

200 gpm injectate water to be diverted from the well to the test skid. The amount of water put through the skid is measured by an orifice plate flow meter and distributed equally to the five test loops (see Figure 6 isometric). Multiple test loops enables several different treatments to be evaluated at the same time.

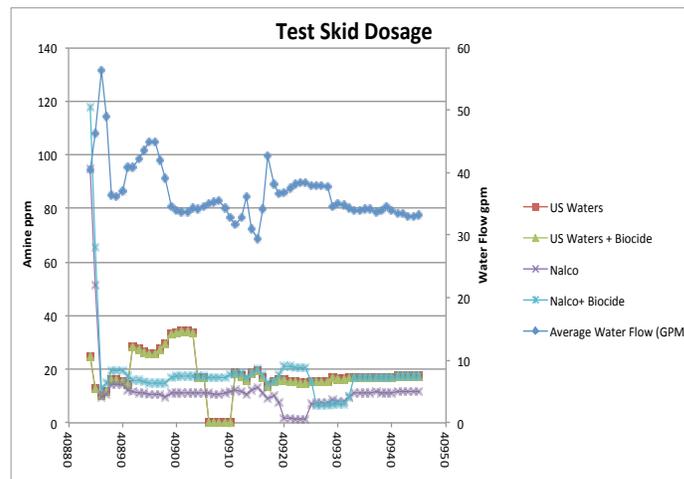
Graph 1.

The trial was relatively trouble free in terms of chemical feed. The most notable upset was a short duration pumping failure on three of the four treated test loops (see Test Skid Dosage graph). When the upsets did occur the corrotors registered no increase in corrosion rates with the lack of amine addition. This indicates that filming amine is quite resilient and will stick to the pipe walls through minor interruptions of feed. The dosages of each treatment are shown in Graph 1:
