Maintenance of Olkaria 1 Additional Units (AU) Power Plant, Kenya

George Ngomi

Kenya Electricity Generating Company

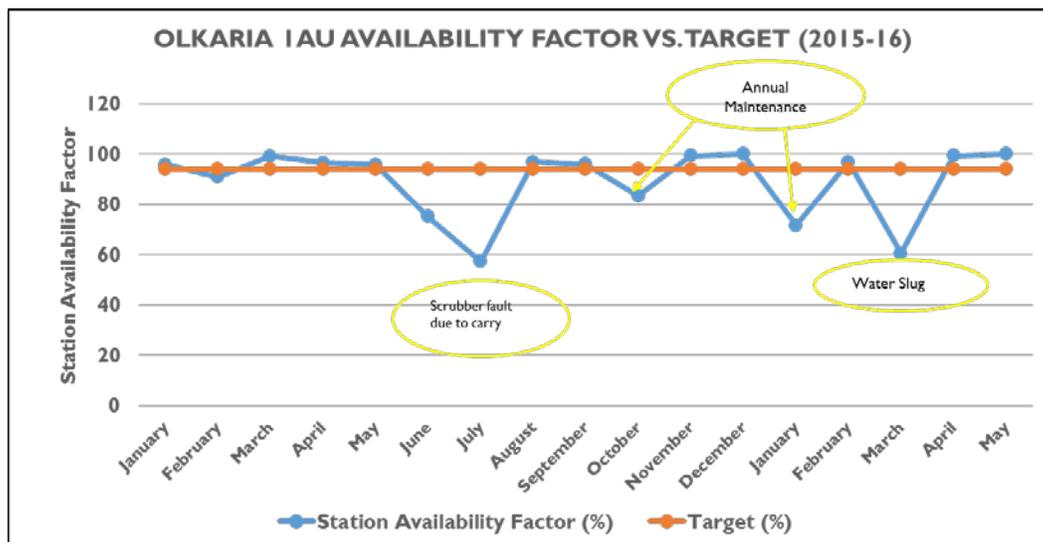
Since commissioning, the plant has encountered maintenance issues ranging from corrosion, silica scaling, slug flow, discoloration and erosion. This is influenced by factors such as fluid chemistry, environment and weather. These issues have led to reduction in efficiency and thus decline in plant performance and availability as shown in Figure 2. For example, carry over from separators due to unreceptive hot reinjection Well no. 13 led to plant trips due to high condensate levels in the scrubber. This also contributed to water slug causing deflection of main steam line support structures.

Figure 2: Station availability factor from January 2015
